## BUILDING & TIMBER PEST INSPECTION REPORT

3 Jemma Pl  
Mona Vale, NSW 2103

04/11/2024

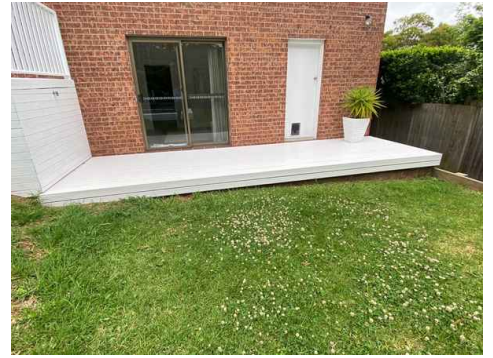
## EXTERIOR REAR VERANDAH

This area is, in our opinion, a high-risk zone that we were unable to fully inspect due to permanent restrictions or locked entry, which prevented access at the time of inspection. **Recommendation:** We strongly recommend further investigation to fully assess and address the risks associated with this high-risk area. Please refer to the accompanying images for further detail.

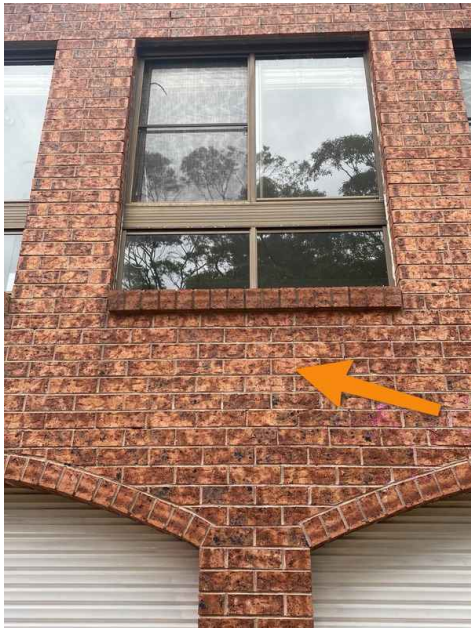
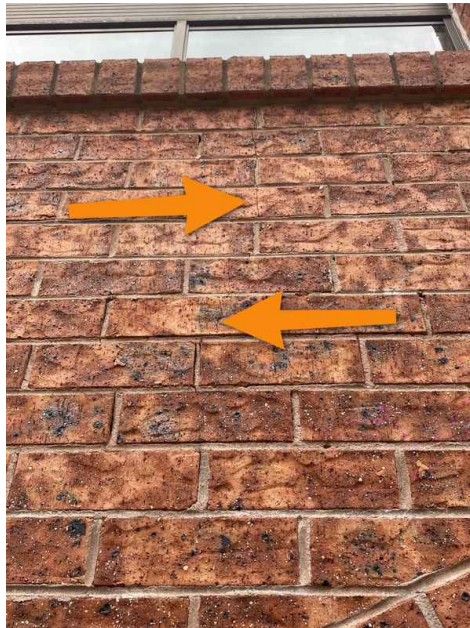
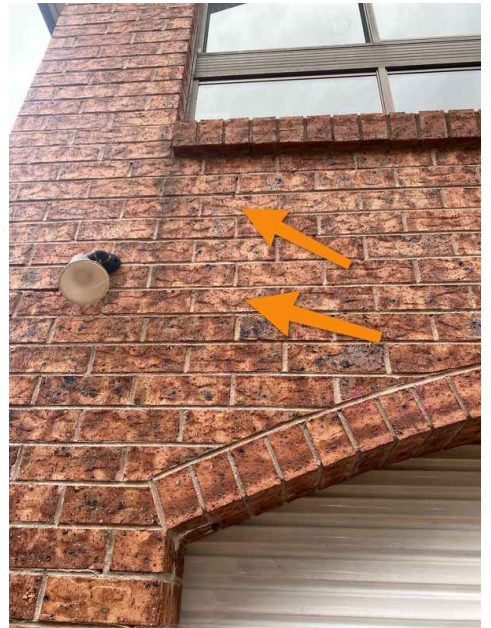
Exterior Over Garage

Priority Defect/Pest Activity**PRIORITY DEFECT – CRACKING IN MASONRY (1MM - 5MM)**

**Type A (Damage)** – Category 2 Cracking (1mm - 5mm) has been observed in the masonry/brickwork wall. In our opinion, the structural performance of the building element is impaired, or the damage is a result of the building's structural behaviour.

In our opinion, these cracks are due to settlement, typically caused by ground movement, which can lead to subsequent movement in building materials.

**Recommendation:** We recommend consulting a structural engineer for further advice on rectification, repair methods and to mitigate further deterioration. Any subsequent work should only be carried out by a suitably qualified trade professional.

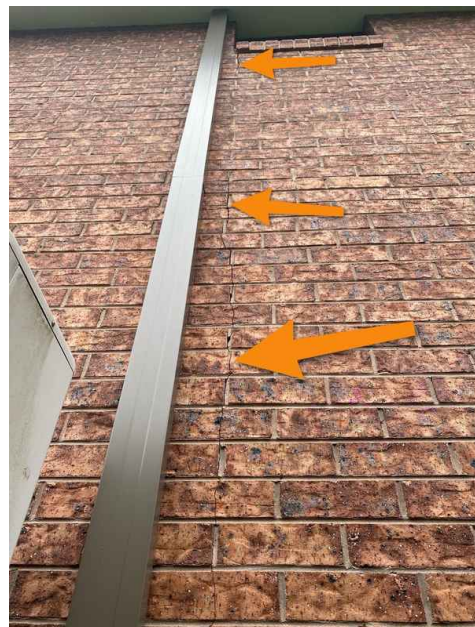
Exterior Left Side

Priority Defect/Pest Activity**PRIORITY DEFECT – CRACKING IN MASONRY (5MM – 15MM)**

**Type A (Damage)** – Category 3 cracking (5mm – 15mm) has been observed in the masonry/brickwork wall. In our opinion, the structural performance of the building element is impaired, or the damage is a result of the building's structural behaviour. Cracks in this category can be repaired, and possibly a small amount of wall may need to be replaced. If left unattended, issues may arise, including:

In our opinion, these cracks are due to settlement, typically caused by ground movement, which can lead to subsequent movement in building materials.

**Recommendation:** We recommend consulting a structural engineer for further advice on rectification, repair, or replacement. Any subsequent work should only be carried out by a suitably qualified trade professional.

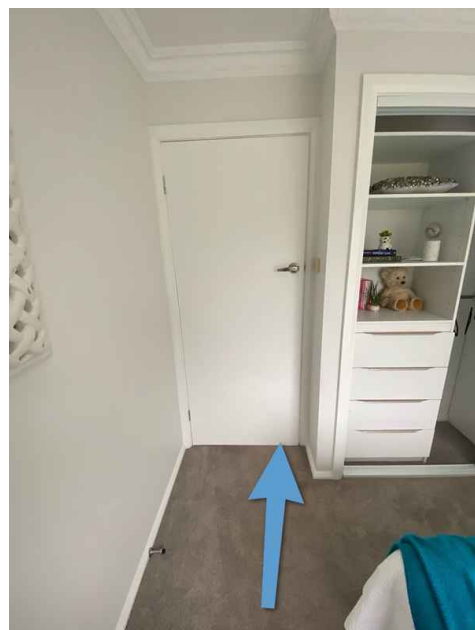
Bedroom Rear Left

Maintenance Defect/Pest Damage**MAINTENANCE DEFECT - OPERATION OF DOOR**

**Type E (Operation)** - The door is binding slightly on carpet and does not operate as intended or designed.

**Recommendation:** Maintenance, repair, or replacement is necessary to restore proper function, and should be carried out by a suitably qualified trade professional.

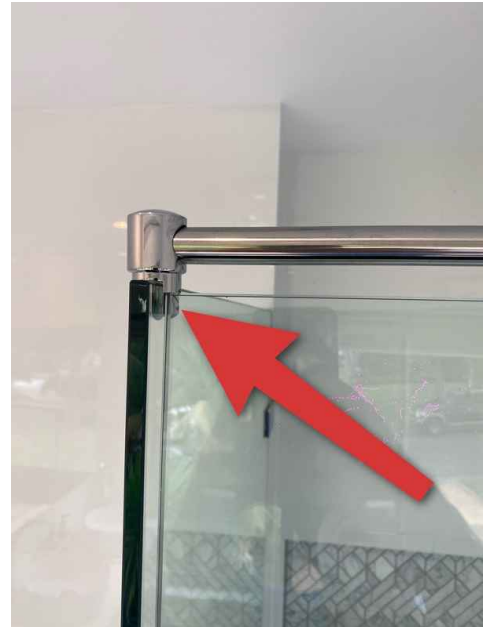
**SAFETY HAZARD - SHOWER SCREEN**

The operation of the glass shower door is obstructed by the metal header bar mount and poses a significant hazard, with a high potential for causing harm to the life or health of individuals.

**Recommendation;** It is recommended that access be restricted as soon as possible, and rectification conducted by a suitably qualified shower screen professional or builder to address this safety concern.

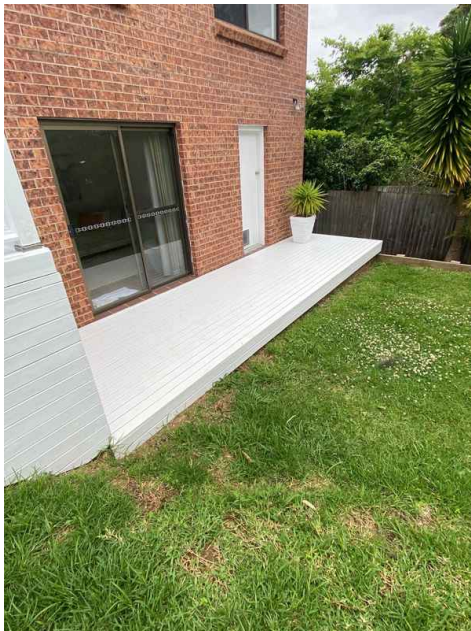
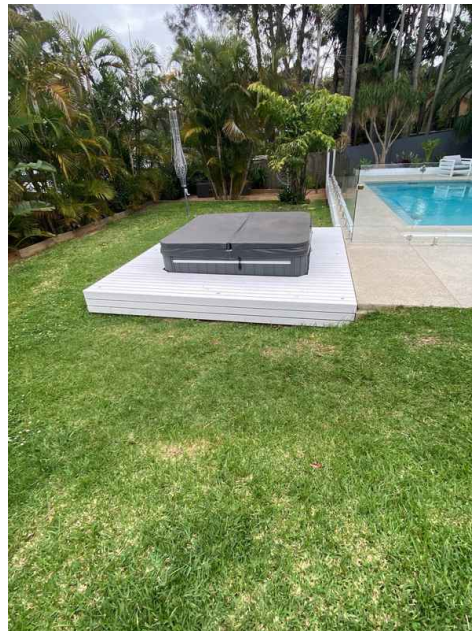
External timber structures found

**Recommendation;** Where external timber structures have been found it is recommended a detailed analysis of the condition and structural stability of the external timber structure by a structural engineer, and;

If people are likely to use the external timber structure, we recommend care is taken not to overload the structure.

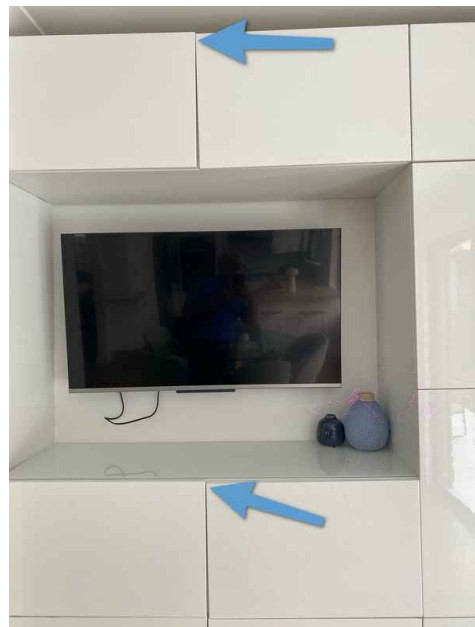
**MAINTENANCE DEFECT - JOINERY OPERATION**

**Type E (Operation)** - The joinery element is malfunctioning and or does not operate as intended or designed.

**Recommendation:** Maintenance, repair, or replacement is necessary to restore proper function, and should be carried out by a suitably qualified joiner/cabinet maker.

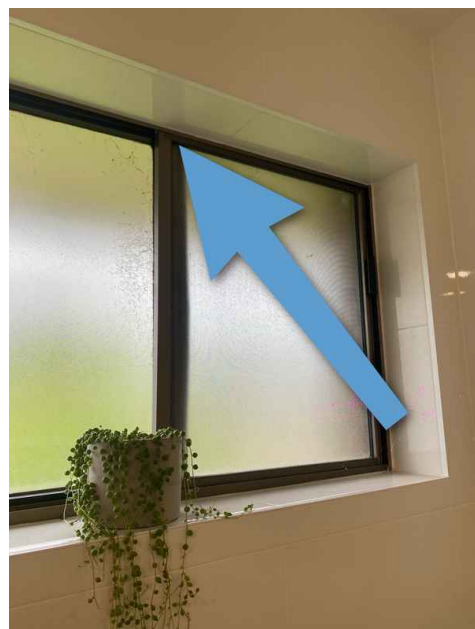
**MAINTENANCE DEFECT - OPERATION OF WINDOW**

**Type E (Operation)** - The window does not close properly or operate as intended.

**Recommendation:** Maintenance, repair, or replacement is necessary to restore proper function, and should be carried out by a suitably qualified trade professional.

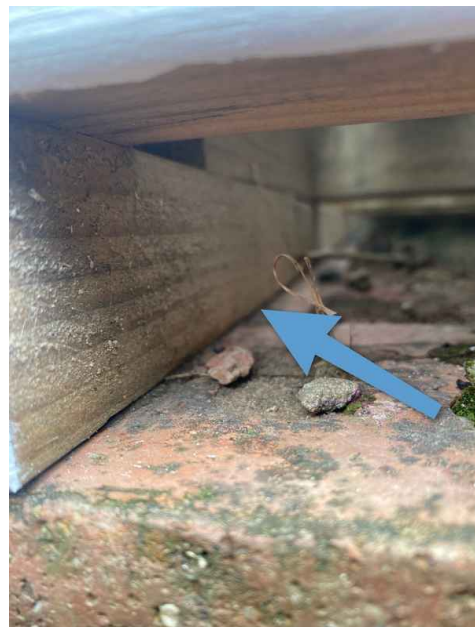
**Type F (Installation)** - Inadequate or missing ant capping found during the inspection, in our opinion, provide a conducive environment for termite attack and infestation. Lack of proper ant capping makes it difficult to detect timber pest activity early.

**Recommendation:** We recommend proper installation or rectification of the ant capping is necessary, and should be carried out by a suitably qualified trade professional.

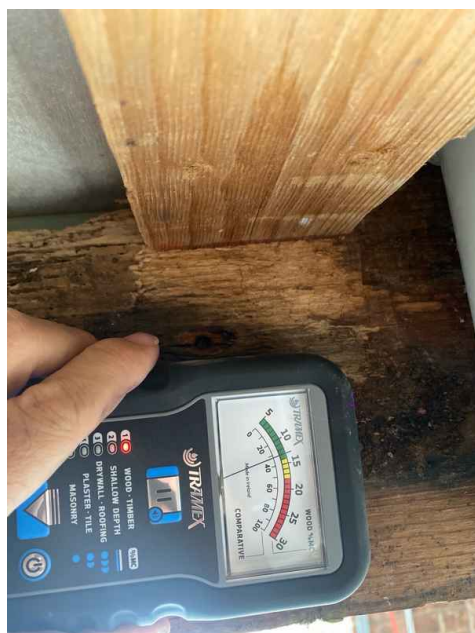
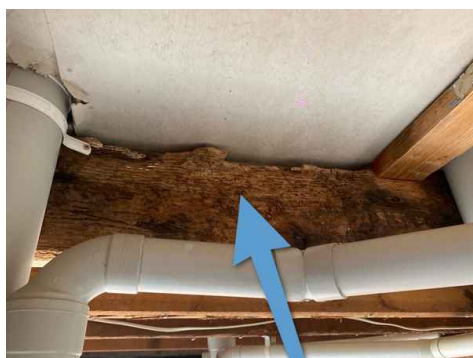
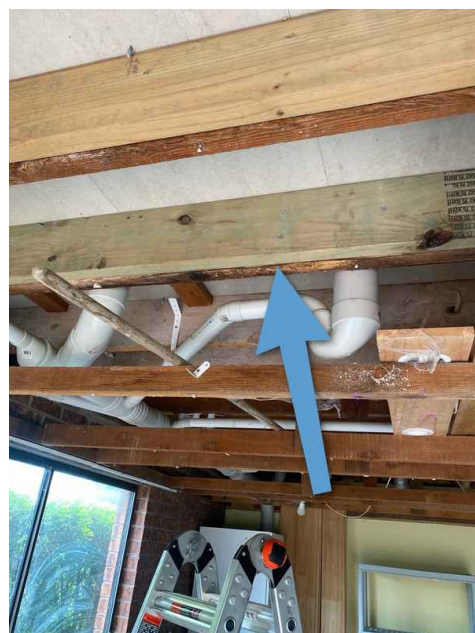
Fungal Decay damage (inactive at the time of inspection) found in timbers in service. Evidence of repairs.

**Recommendation:** We recommend removing or replacing identified items with alternative moisture resistant materials by suitably qualified landscaper.

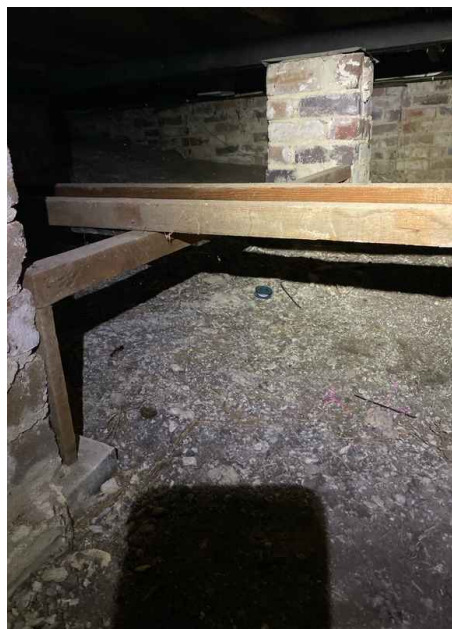
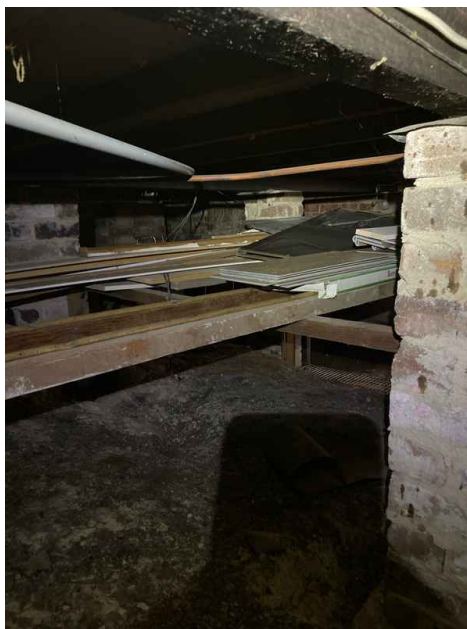
Subfloor

Stored wood, timber, or firewood located close to the building provides a food source for termites, increasing the risk of infestation. Wood and/or timber items found during the inspection, in our opinion, create an environment conducive to timber pest attack and infestation. Refer to the images provided for additional information, identification, and representative examples of these conducive conditions.

**Recommendation:** We recommend removing all identified and any similar items, thereby reducing the risk of timber pest infestations.

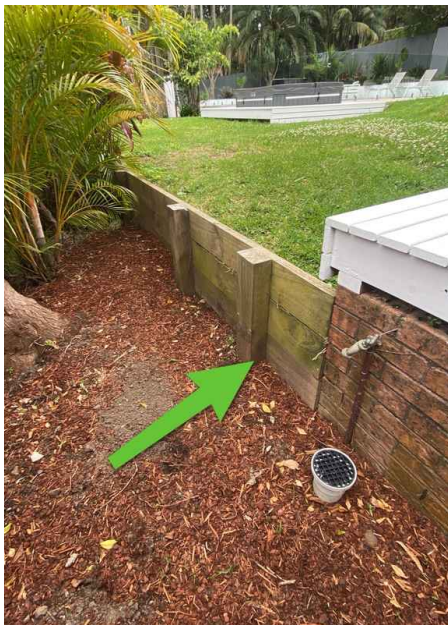
Site Rear Left Side

Timbers in service found during the inspection in ground contact, in our opinion, provide a conducive environment for timber pest attack and infestation. Timbers in direct contact with the ground promote moisture uptake, creating an ideal environment for Timber pest infestation. Refer to the images provided for additional information, identification, and representative examples of these conducive conditions.

**Recommendations:** We recommend removing or replacing all identified timbers and similar components with suitable resilient materials, or reconfiguring the structure to achieve a minimum 75mm ground clearance, thereby creating a suitable inspection zone.

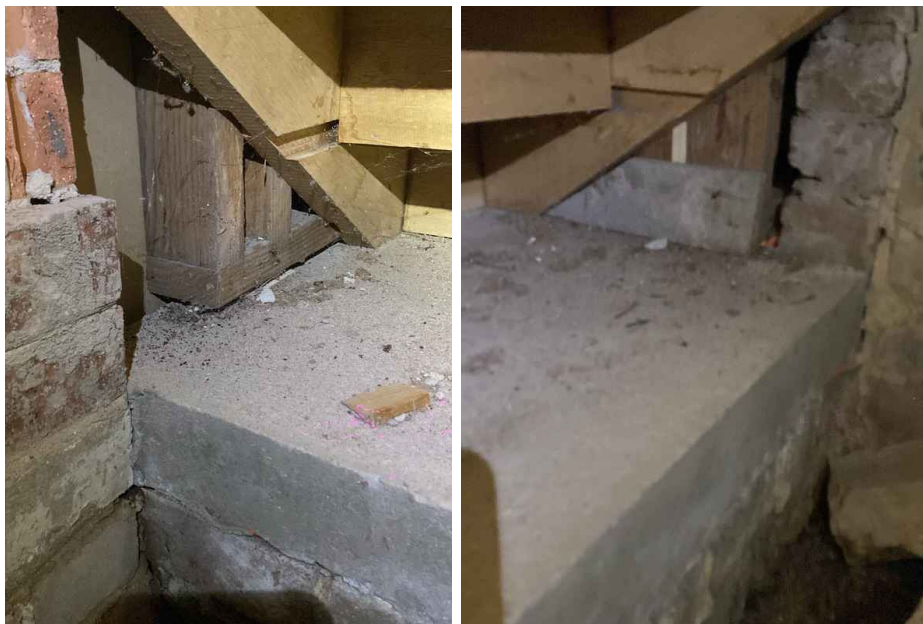
Our inspection revealed building elements that, in our opinion, pose a risk of undetected termite entry or activity. Refer to the images provided for additional information, identification, and representative examples of these conducive conditions.

**Recommendation:** We recommend that all identified and similar elements be removed, reconfigured, or replaced with suitable alternatives that prevent termite entry or alternatively provide adequate inspection zones. All work should be carried out by suitably qualified trade professionals.

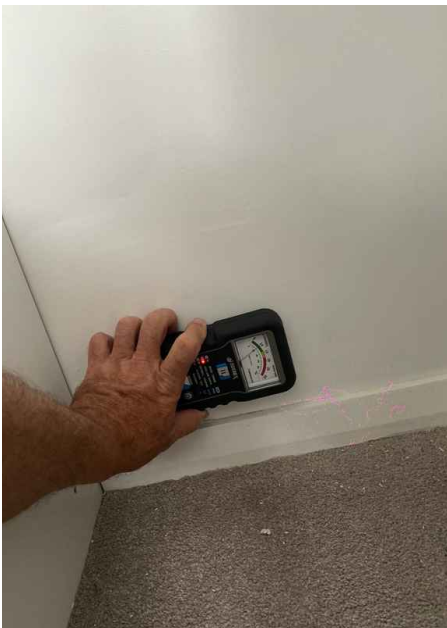
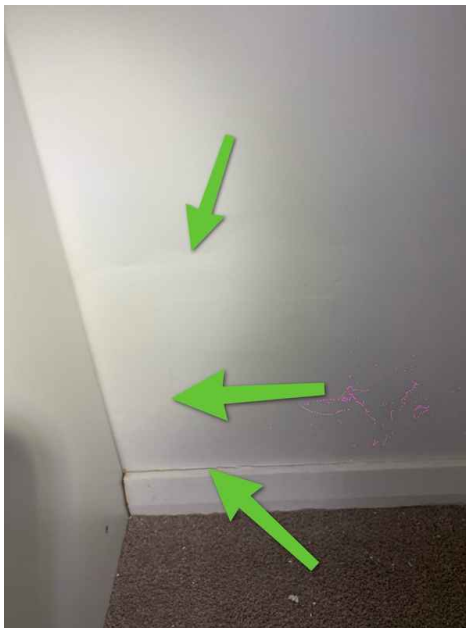
Bedroom 2, behind bathroom shower area.

Evidence wall has been patched behind bathroom shower. No elevated moisture levels present at time of inspection. It appear the bathroom has be recently replaced. It is not clear if this wall repair was carried out before or after any bathroom renovation.

**Recommendation;** Monitoring for evidence of moisture. If moisture becomes apparent it is very likely a result of failure to the waterproofing.
