## BUILDING & TIMBER PEST INSPECTION REPORT

3 Jemma Pl  
Mona Vale, NSW 2103

04/11/2024

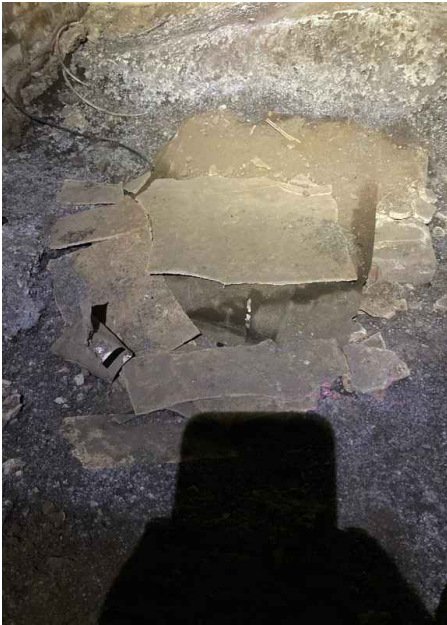
**General: Possible concealment**

Bedroom 2, behind bathroom shower area.

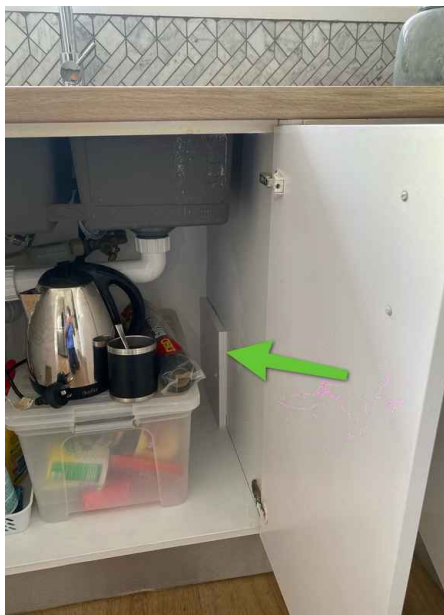
### Built-in Appliances: Appliances - Powered-On

Cooktop, Oven, Rangehood, Dishwasher, Microwave
